AN INTERESTING CASE STUDY OF COMBUSTION TUBE FAILURE

BACKGROUND

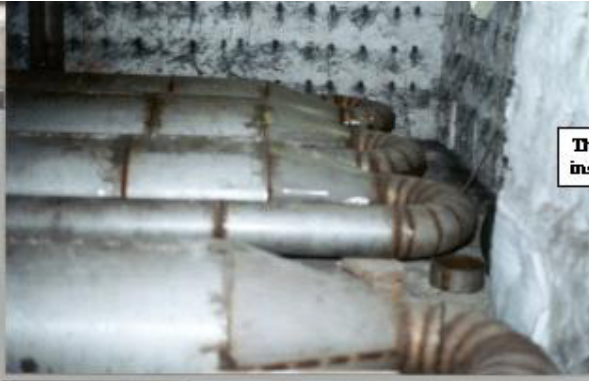
The new ducting installed

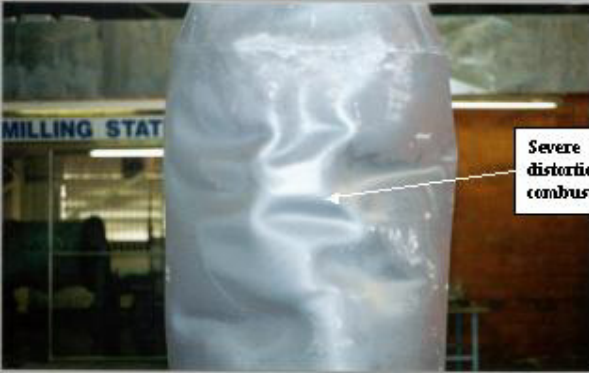
Thermal stresses induced from over-heating and cooling result in the localised buckling that can be seen on the ducting. Temperatures in excess of 1200°C

will cause the steel to expand and creep unevenly and then shrink unevenly causing further distortion.

An inspection of the flue ducting showed severe distortion (buckling), discolouration and heavy scaling. A duct was seen to have an extensive circumferential crack. An amount of particulate matter was removed from the ducting. This material was magnetic and identified as ferrous/ferric oxide⁽³⁾ being a product of oxidation of the steel. The material was sent to the laboratory to determine the amount of carbon present at the request of the customer to confirm that it is not un-burnt fuel.

1. It would appear that the operating temperature of the stainless steel ducting had been in excess of the recommended limits of 1000°C – 1100°C⁽²⁾. This resulted in extensive distortion taking place and accelerated the oxidation rate of the steel, which greatly reduces the life of the steel.
2. Due to the higher radiance flame of LO10 over that of paraffin, the LO10 is likely to be more efficient at transferring heat and will heat the

Severe heat induced distortion evident on combustion duct

3. Temperature probes on the combustion tubes are required to ensure that the maximum acceptable temperature is not exceeded. This would have prevented the damage from the higher radiance fuel and from the increased heat input from changing to larger nozzle size.

4. The burners should be set with optimal oxygen content to ensure that the flue gas is not unnecessarily oxidising. This can be achieved with the use of a combustion gas analyser to set the burners to achieve optimal oxygen (<1-2%0, CO₂ (maximum) and CO (<10 ppm) content. This will have the added benefit of improving fuel efficiency, which will save money, and reducing harmful flue gas emissions.

5. Excessive cycling of the burner operation and rapid heating and cooling will significantly reduce the life of the steel. Burner nozzles should be optimally sized to limit excessive cycling.

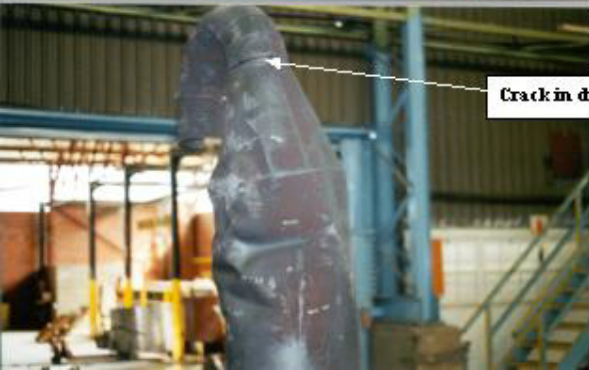
Crack in duct
